Field Investigation of Flexible Pavement Rutting Damage Using the Transverse Surface Profile

Mahmoud El-Saied Solyman¹ and Hassan Salama²

Keywords: Pavement rutting, transverse surface profile, Layer rutting, field investigation, truck traffic.

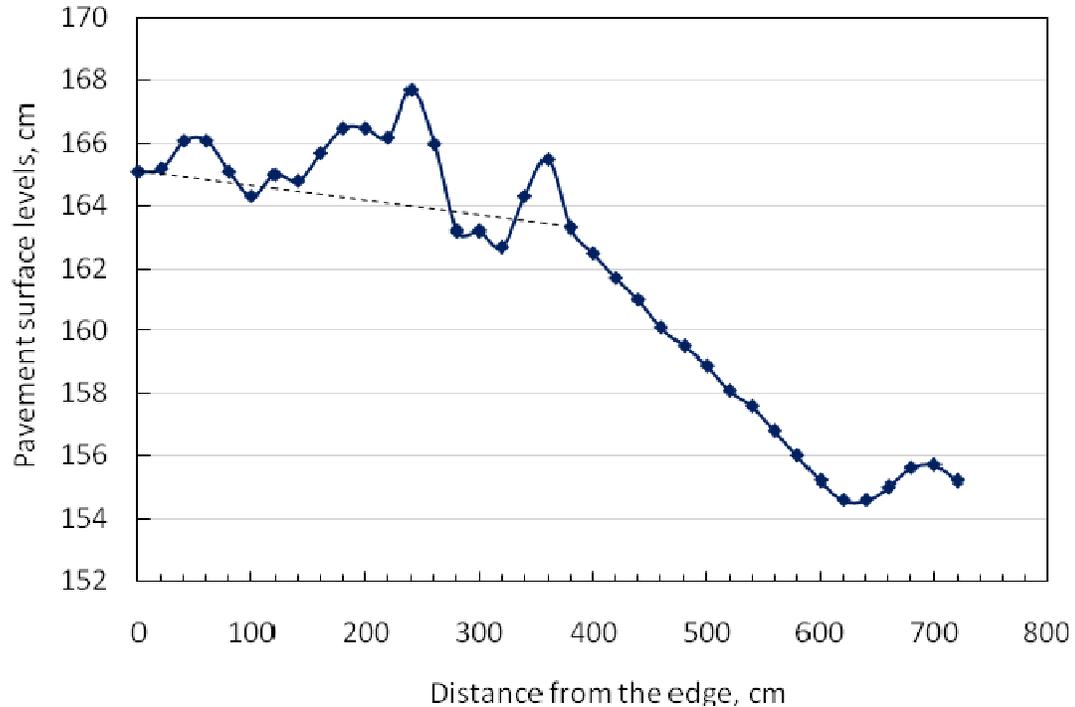
Figure 2. Actual transverse surface profile measurements at section 6

The transverse surface profile at 10 sections on Belbis – Zagazig Road was measured. 9 sections were taken in the North bound (toward Zagazig) where majority of the trucks are fully loaded with construction materials whereas only one section was taken in the south bound. The road levels in the transverse cross sections at each intersection were measured using the rod and level each 20 cm for the entire direction. These levels were used to form the transverse surface profile of the road. Also, the maximum rut depth in each section was measured. Figure 2 shows the process of measuring the transverse surface profile and the maximum rut depth. Since the truck drivers do not always stick to the right lane of the road, the traffic lane that shows higher rutting distresses was considered in the analysis. Figure 3 a and b shows the survey of the transverse profile and the measurement of the maximum rut depth.

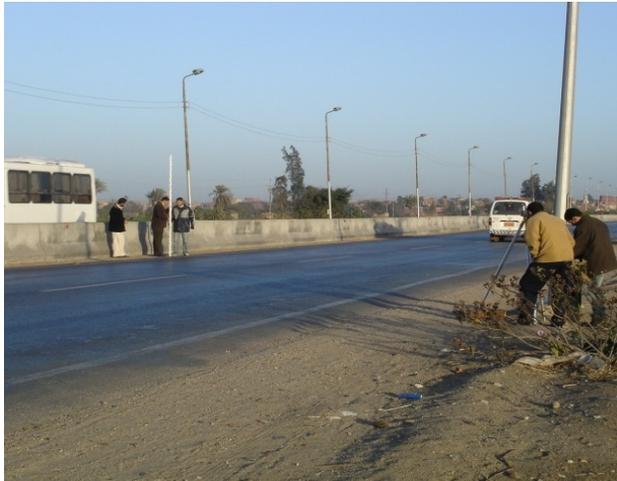
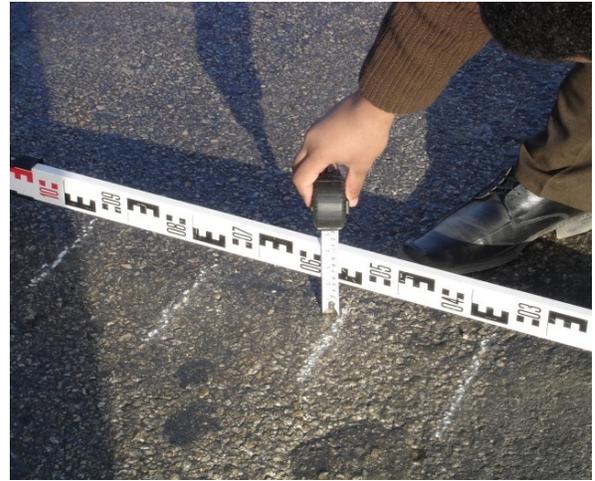
Figure 3. Transverse surface profile measurements**Analysis**

(a) Survey the transverse surface profile

(b) Measuring the maximum rutting

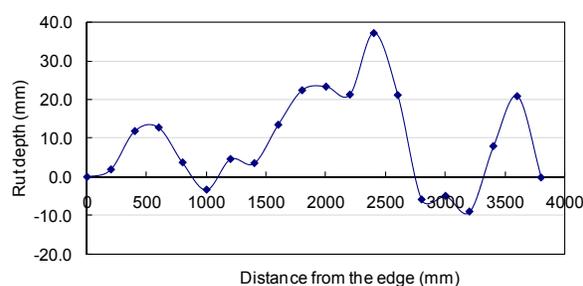
(a) HMA rutting – Section 6

Analysis of the transverse surface profile indicates that there are construction-related rutting and structure rutting. All sections that have rutting failure in hot mix asphalt layer are due to construction-related problem. This is due to the premature rutting problem that has been appeared at the early stage of the pavement life. Moreover, investigation of the construction files of the road indicated that there were

problems in the asphalt plant where the asphalt feeder was not accurately calibrated to supply the optimum asphalt content. On the other hand, sections that have failed in base and subgrade are due to the fact that the structure capacity of the pavement under-designed to carry the traffic load and about 35.42 millions ESALs are more than what the cross section can carry. Also, comparing the rutting damage in both directions of the

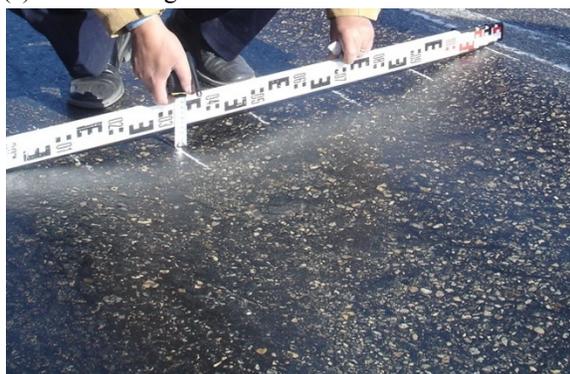
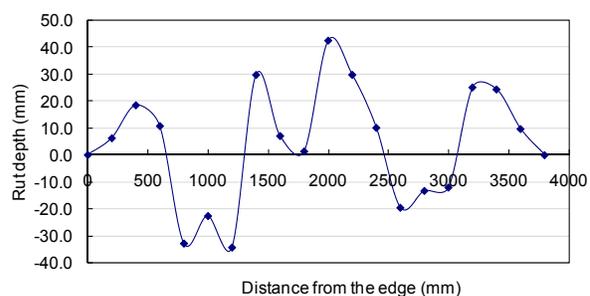
(b) HMA Rutting –Section 7

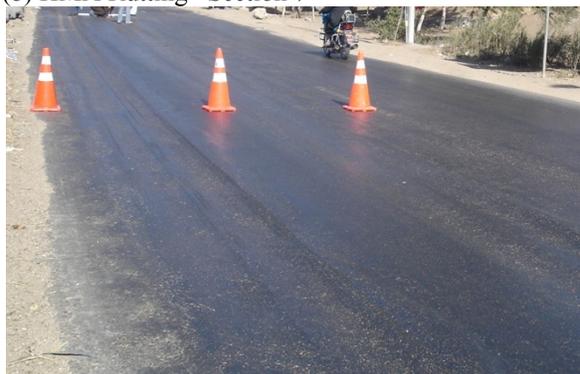
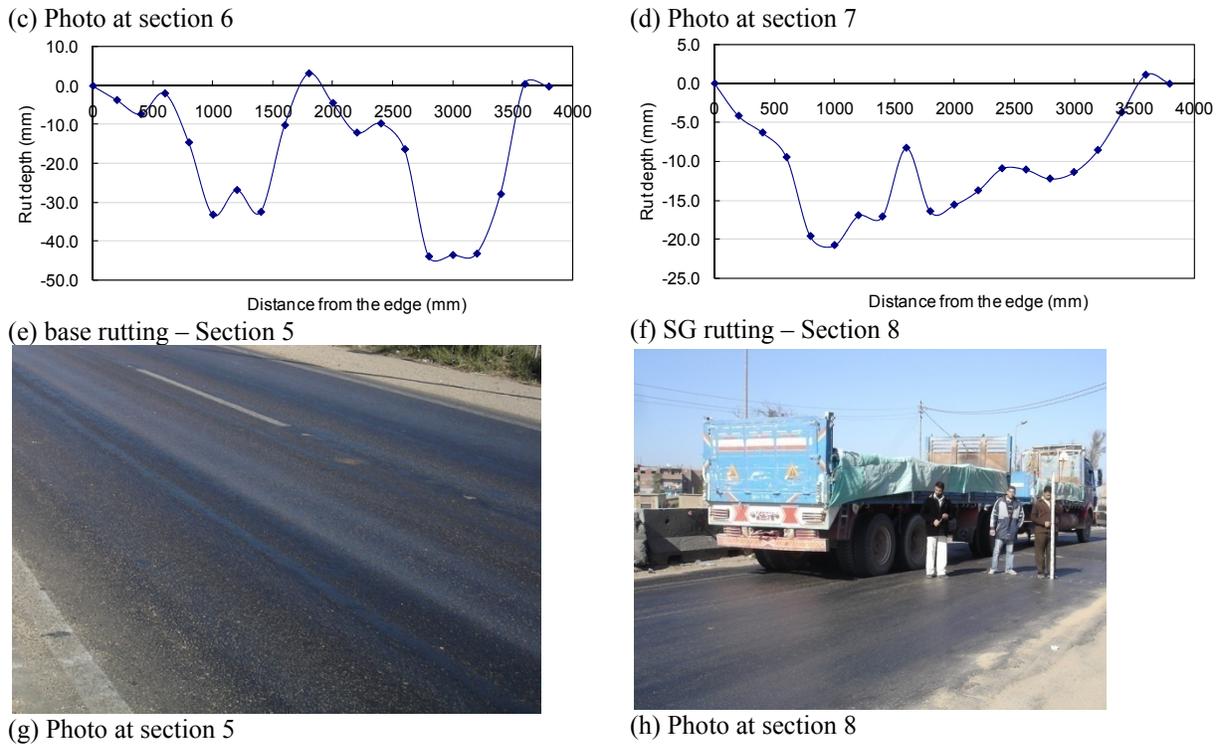
Figure 5. Various rut mechanism at different locations along the road

layer at each intersection. Table 3 shows the transverse surface profile parameters calculations for the ten sections. Figure 5 shows examples of each failure mechanism for different pavement layers along with photos for these sections. The transverse surface profiles analysis of the road segment showed that 60% of the failure occurred in the hot mix asphalt, 30% of the failure on the base layer, whereas 10% on the subgrade layer. This indicates that rutting resulting from the pavement layers represent 90% along the road segment. In addition the only section that shows failure in the subgrade layer was on the border between the base and subgrade failure. These results show that the main rutting problem in this road mainly related to pavement layers.

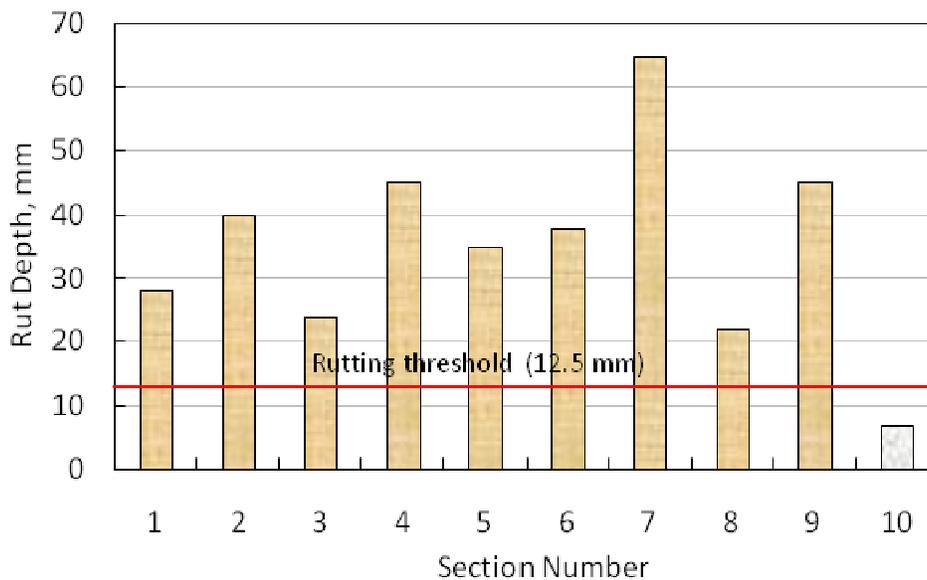
Figure 6. Maximum rut depth on the transverse surface profiles

Since majority of the trucks drive in the left lane, the analysis indicated that 8 sections out of 10 had rutting failure in the inner lane which consider as the truck lane. All 9 sections in the north bound (toward Zagazig) are showed maximum rut depth more than 22 mm which is higher than the failure threshold. This indicates that the heavy truck traffic load is one of the major factors that cause the north bound to have major rutting problem. Section number 10 located in the South bound (toward Belbis) where most of the truck traffic are empty showed maximum rut depth 7 mm which is less than the rutting failure threshold. Figure 6 shows the maximum rut depth for the ten pavement sections.

road support this conclusion where the maximum rutting the unloaded direction still did not exceed the threshold of the rutting failure criteria (section 10 – see Figure 6).
