## Repair Welding Restoration of the Screw Conveyor for Resin Extruder

**Abstract:** A screw conveyor was exposed to an extensive wear at the top and the side surfaces of the teeth. The microstructure of the base metal is martensitic structure. Welding procedure specification (WPS) and Process Qualification Record (PQR) were carefully performed using a scraped part from the screw conveyor. The preheating temperature of 300 to 400 °C was applied and the SMAW process was selected as selected as a welding process. Three types of electrodes were selected which mainly wear and corrosion resistance type. Using chromium Carbide electrodes resulted in a significant appearance of cracks at the weld surface that extended to the heat affected zone. However, Using martensitic electrodes resulted in a crack free weld metal with a significant improve of the wear resistance of the base metal. The effect of applying cushion layer between the base metal and hardfacing layer were studied using two kinds of covered electrodes. The hair cracks that observed using the hardfacing electrodes were greatly reduced using these cushion layers. The results were discussed on the basis of microstructure and th

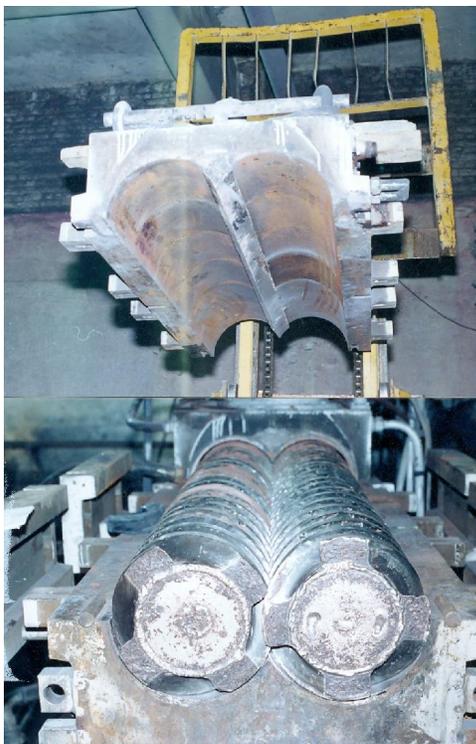
the complete structure of the extruder and the location of the pair of screw conveyor. The tooth outer surface is exposed to mainly abrasion wear and their diameter was decreased by 10 mm. Also, the side part of the tooth was exposed to worn especially at the mid length of the screw conveyor.

**Fig. 1 Complete structure of the extruder and the location of the screw conveyor**

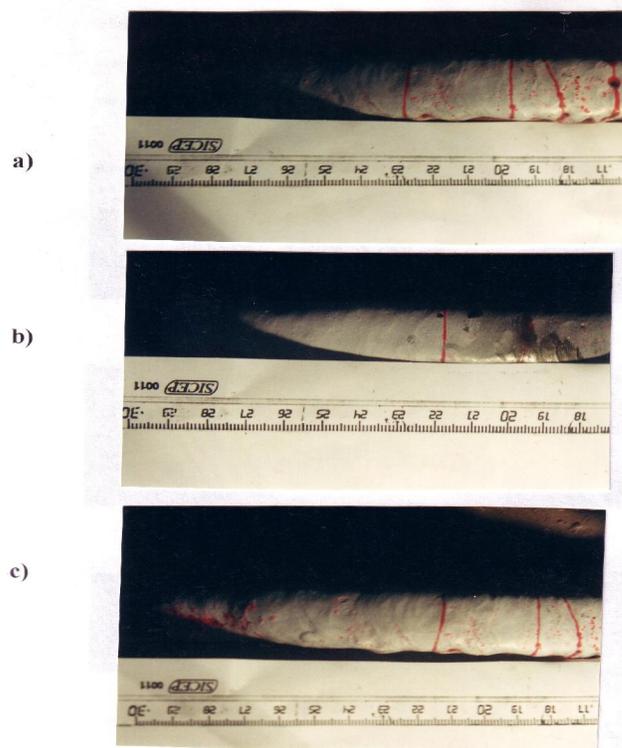
Application of five layers of electrode C resulted in a formation of transverse surface cracks as detected by dye-penetrant test (Fig. 2a). The same results were obtained with the use of electrode B. However, the crack density significantly decreased than that obtained using electrode C as shown in Fig. 2b. A crack free-weld was obtained with the use of electrode A as shown in Fig. 3 a.

**Fig. 2 Transverse surface cracks by dye penetrant test**

- Using electrode C (five layers),
- Using a cushion layer E and 2 layers of electrode C
- Using electrode B (five layers).

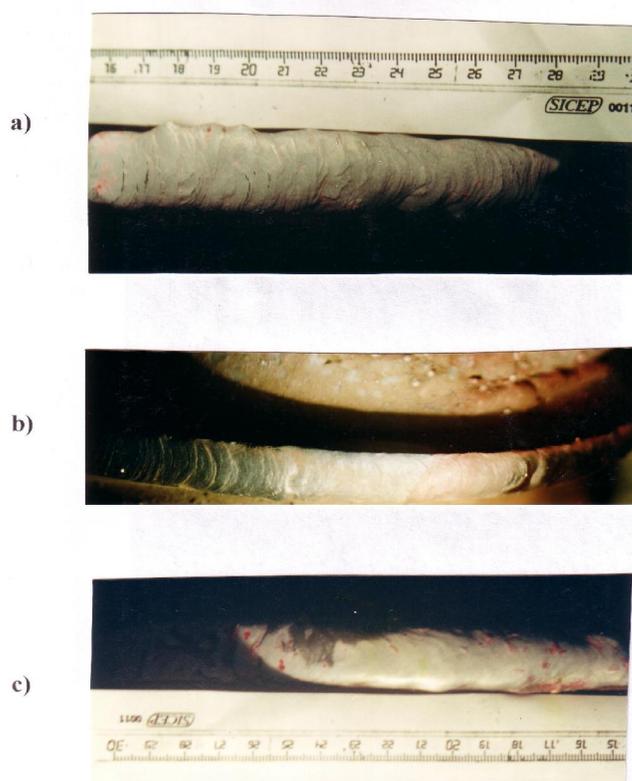
The effect of application of a cushion layer using electrode D and E (Table 2) between the base metal and the hardfacing layers on the soundness of weldment was also studied. Using cushion layers of electrode D (Fig. 3b) or electrode E (Fig. 3c) between the base metal and the hardfacing layers (three layers of electrode B) resulted in a significant decrease in the density of transverse cracks than that obtained without application of cushion layer (Fig. 2c). Application of cushion layer using electrode E between the base metal and the hardfacing layers of electrode-A in welding of the whole screw conveyor resulted in the disappearance of the transverse cracks

**Fig 3** weld beads free from cracks as detected by dye penetrant test

- a) Using electrode A (five layers),
- b) Using a cushion layer D and 2 layers of electrode B
- c) Using a cushion layer E and 2 layers of electrode B

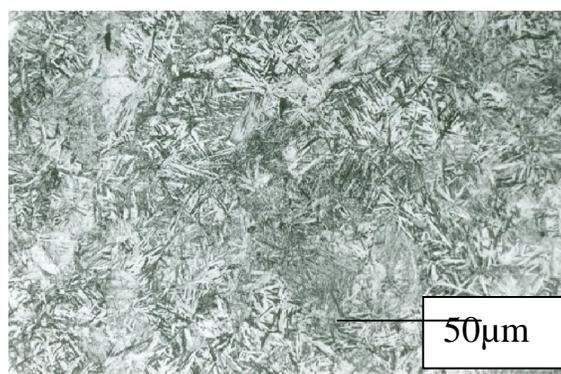
The microstructure at the cross section of the teeth of the screw conveyor is shown in Fig. 4. It is martensitic structure.

**Fig. 4** Microstructure of the screw conveyor

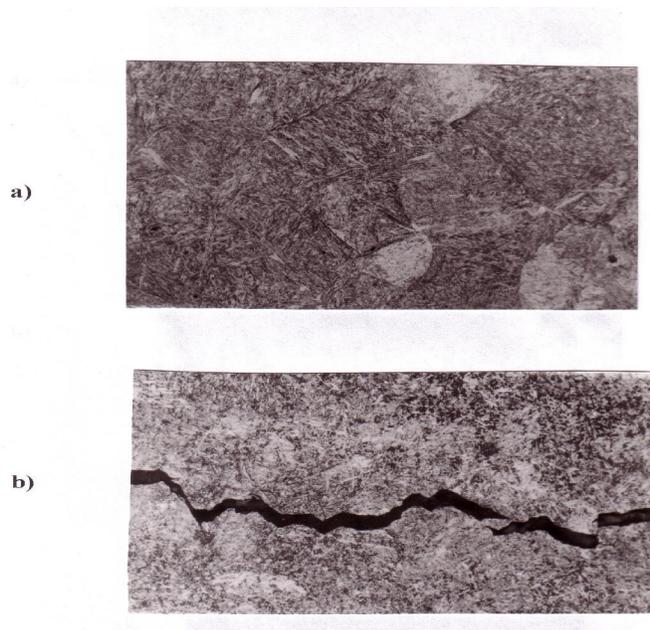
Welding of the whole screw conveyor was conducted with the same welding procedure using electrode A. Dye-penetrant test shows a few transverse surface cracks distributed along each teeth surface. These cracks are extended to the heat affected zone as shown in Fig. 5 b. This could be attributed to the accumulated thermal stresses and the constraint associated with the welding of the whole screw conveyor.

The microstructure of the heat affected zone in the crack free specimen is shown in Fig. 5a. The microstructure reveals the existence of coarse martensite. The microstructure of the heat affected zone in the cracked specimen is shown in Fig. 5b. It is also a coarse martensite.

**Fig. 5** Microstructure at the HAZ of the base metal a) Crack free specimen,

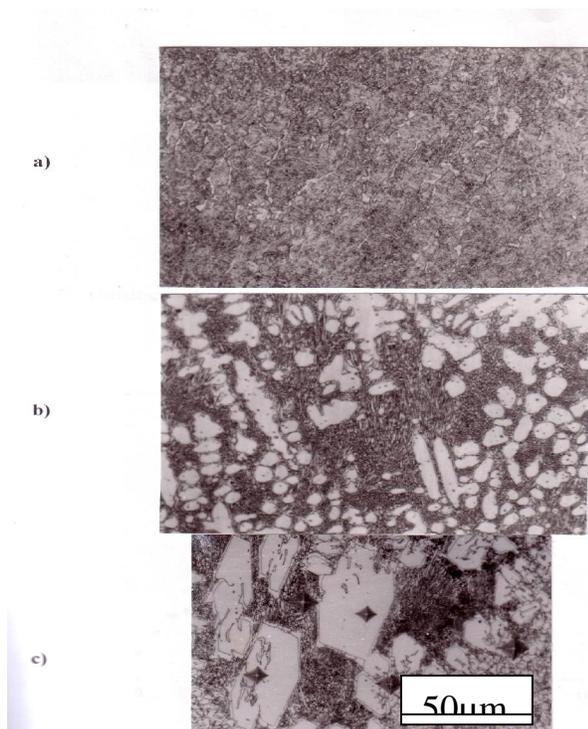
The microstructure at the top surface of the weld metals using electrode A, B and C are shown in Fig. 6a, b and c respectively. The microstructure of the weld metal using electrode A reveal the martensitic structure (Fig. 6a). The microstructure of the weld metal obtained using electrode B shows austenite with eutectic carbide (Fig. 6b). Weld metal microstructure obtained using electrode C shows the existence of Cr-carbides with austenite eutectic carbide matrix (Fig. 6c). The chromium carbide using electrode C is much coarser than that obtained using electrode B. It is already decided that the coarser the carbide the higher the wear resistance of the hardfacing layer (4).

**Fig. 6** Microstructure at the top surface of the weld metal using a) Electrode A, b) Electrode B, and Electrode C

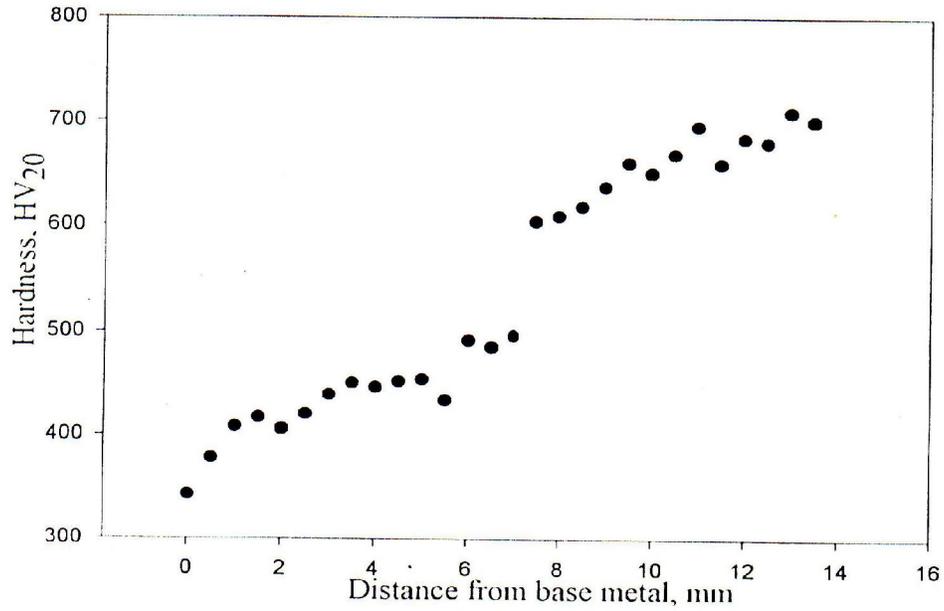
Hardness distribution through the cross section of weld using five layers of electrode A is shown in Fig. 7. The hardness values increased from the base metal to the heat affected zone and then

gradually increased to near 700 Hv<sub>20</sub>. The hardness distribution through the cross section of the weld using two layers of electrode E followed by three layers of electrode A is shown in Fig. 8. The hardness value increased from the base metal to the heat affected zone (more than 500 Hv<sub>20</sub>) and then decreased to more than 200 Hv and then increased gradually to more than 500 Hv<sub>20</sub>.

**Fig. 7** Hardness distribution along the base metal, HAZ and hardfacing material using electrode A

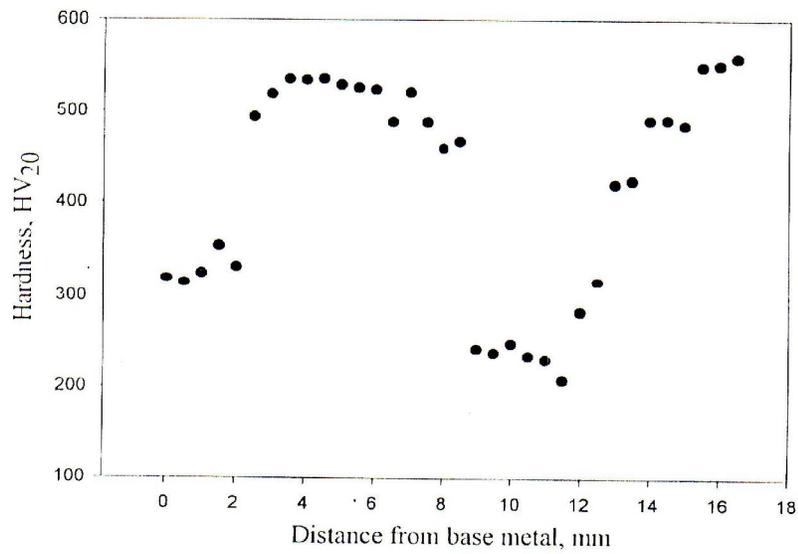
**Fig. 8** Hardness distribution along the base metal, HAZ and hardfacing material using electrode E and three layer of electrode A.

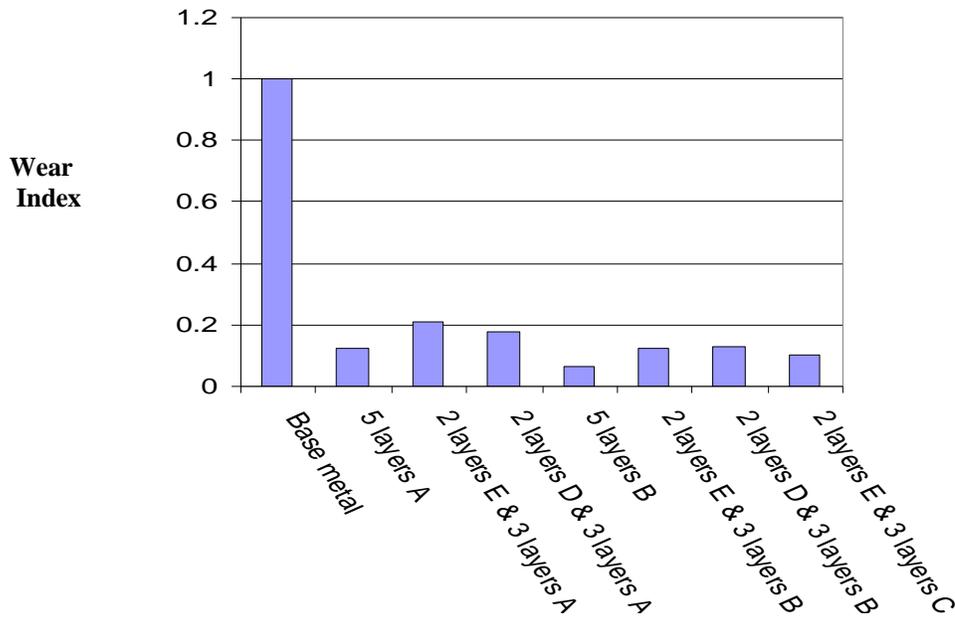
The wear index of the base metal and the different weld deposits are shown in Fig. 9. The wear resistance of all the weld deposits is much better than that of the base metal. Wear resistance of electrode B and C deposits is much higher than that of electrode A deposit.

The higher the difference in hardness between the abrasive particles and the hard phases in the matrix of microstructure the lower the wear resistance and the higher the wear index value (Fig. 9). The microhardness of the alumina particle is about 2100 Hv (5).

From the forgoing results, it is preferred to apply electrode A (martensitic structure) since its deposit has both the characteristics of crack free and high wear resistance. The use of cushion layer before applying electrode, A resulted in a decrease in the wear resistance as shown in Fig. 9. This obviously appears when the pair of screw conveyor was put into service.

**Fig. 9 Wear index for base metal and hardfacing layers**
