Improving Punching Shear Behavior of Flat RC Slabs

[Omar El-Nawawy, Ayman Hussein Hosny, Eiad H.Zahran and Hamada Ali Hamada Mohamed. **Improving Punching Shear Behavior of Flat RC Slabs.** *J Am Sci* 2015;11(7):122-129]. (ISSN: 1545-1003). <http://www.jofamericanscience.org>. 15

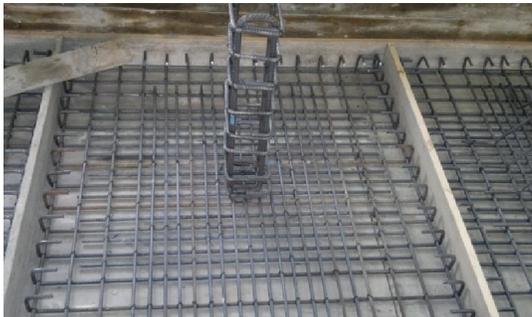
Figure (3): Details of Specimens Casting Forms

Wooden forms were used. They were coated with oil film before concreting the reinforcement was then placed in their position in the forms. Special supporting bars are placed to hold the reinforcement at the proper position and were removed soon after the concrete was poured. Concreting took place immediately after mixing. A mechanical vibrator was used in placing the concrete around the reinforcing bars together with the hand tamping and rodding to ensure full compaction.

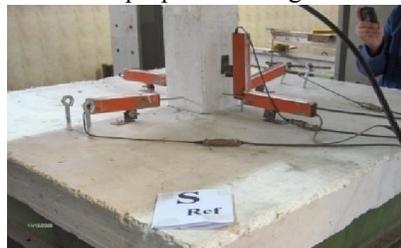
Fig (5): Locations of vertical LVDT'S

verticality. The LVDTs positions of the control specimen as shown in Fig (5)

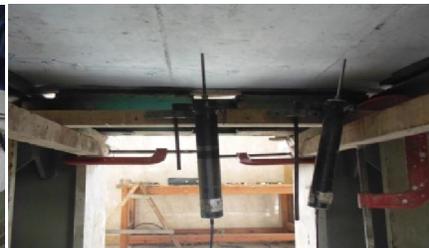
Fig (6): Locations of vertical LVDT'S

To record specimens concrete vertical deflections, vertical LVDTs were used below slab-column specimens at two different locations measured from centerline of the slab as shown in Fig (6).

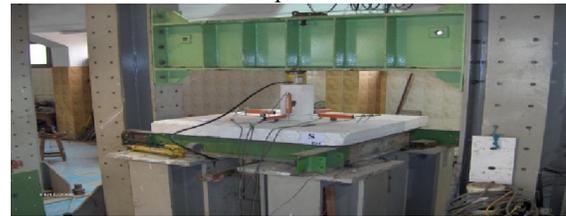
Fig (9): Test setup

Two days before testing, Slabs were painted with a white lime solution to facilitate cracks detection. The slab specimens were mounted in a horizontal position in the loading frame and the load was applied to the stub-column in a vertical direction fig (9).The load was applied using an hydraulic jack of 100 ton or 200 ton capacity provided with and electrical transducer attached with a digital screen for the load reading. Load was applied on successive increments. Slab deflection, steel strain of shear reinforcement
