## Prevention of cold cracking in ASTM A516 Gr. 70 steel weldment

**Abstract:** Cold cracking susceptibility was studied in welding of ASTM A516 Gr. 70 steel using AWS A5.1 E7018 electrode. Y- Tekken cracking test was applied to study the effect of preheating and heat input on cracking index. Application of preheating temperature of 150<sup>0</sup>C resulted in a disappearance of cracks. Also, increasing the heat input from 0.89 kJ/mm to 1.34 kJ/mm significantly decreasing the cracking index. Increasing the drying temperature of covered electrode has a significant effect on decreasing the diffusible hydrogen content. Cold crack started at the HAZ root (Martensitic structure) and propagated through the fusion line to the weld metal. Fracture surface observation by SEM indicating transgranular cleavage fracture at the fusion line (HAZ), quasi cleavage fracture at the transition zone ahead of fusion line and a ductile fracture at the weld metal.

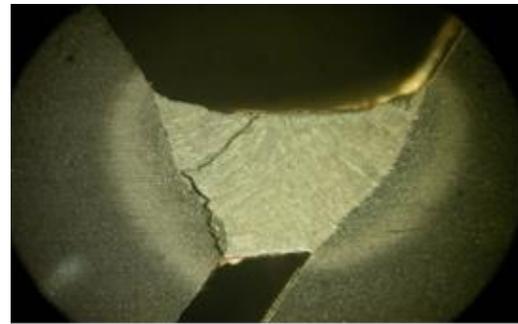
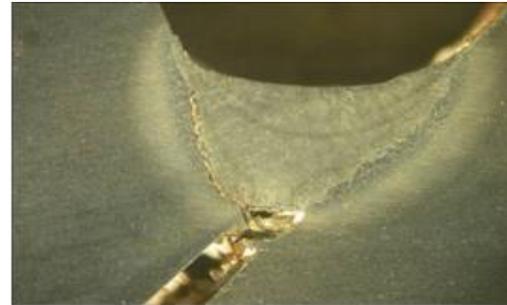
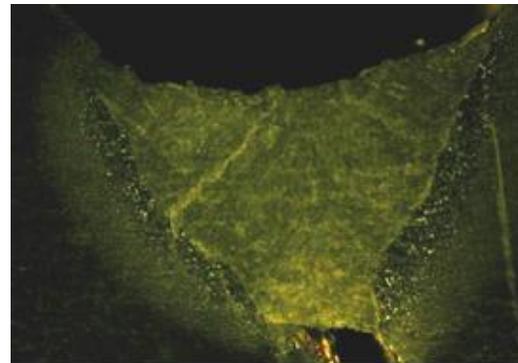
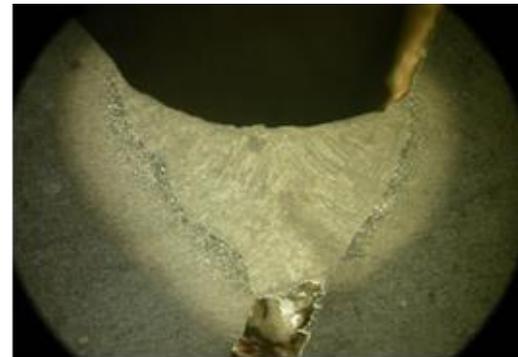
**Figure 4** show some examples of cross sections of the cold cracking test using different condition of preheating and drying condition of covered electrode.

**Fig. 4** Macrostructures of the cross sections of cold cracking test using a) Welding without drying, b) Welding with drying at 300 °C for 2 hours, c) Welding without drying and preheating at 150 °C and d) Welding with drying at 300 °C for 2 hours and preheating at 150 °C

Most of cracks were observed at the heat affected zone and propagated through the fusion line to the weld metal as shown in Fig.10 (see also the macrostructures of the cracked specimens in Figs. 4 a, b and c). It is started at the root of the HAZ (fusion line) and propagated in the HAZ and weld metal and terminated at the weld surface as shown in Fig10.

subsequent reduction in hardness of its martensitic structure as shown in Fig. 12. Also, preheating accelerates hydrogen removal and decrease the residual stress<sup>(12)</sup>. This reflect the disappearance of cold cracking (crack index = 0) at the preheated test specimen as shown in Figs. 3 and 4.

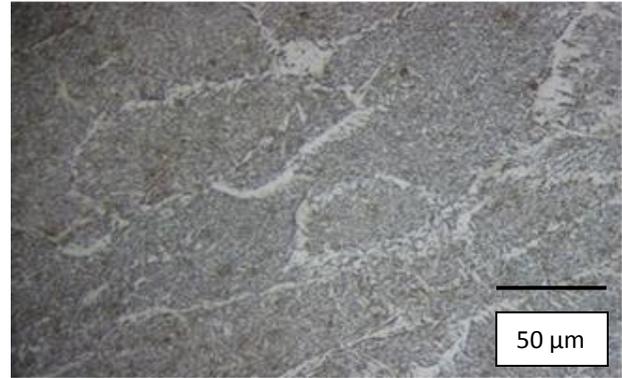
Microstructure of the weld metal of the cold cracking test spacemen welded using AWS A5.1 E7018 electrode is shown in Fig.7. It is a columnar structure containing acicular ferrite (AF) with some grain boundary ferrite (GBP).

**Fig. 7** Microstructure of the weld metal using AWS A5.1 E7018 electrode

(Fig. 14), the fracture surface is a transgranular cleavage fracture (brittle fracture) surrounded by nets of dimple strips, corresponding to the size of prior austenitic grains. The cleavage regions in the fusion line indicated the presence of high embrittlement due to the increase in the hardness values as shown in Fig. 11. The fracture surface at the transition zone ahead of fusion line showed quasi-cleavage morphology as shown in Fig. 15. Inside sub-grain region, there are several cleavage facets with small parallel tear ridges as shown in Fig. 15. The tear ridges inside indicate that the cracks were initiated inside the sub-grains at the interface between ferrite matrix and cementite particles. The mixed quasi-cleavage and ductile mode in this region confirming the absence of severe embrittlement. On the other hand, the fracture surface at the weld metal shows ductile dimpled fracture mode as shown in Fig. 16. The strong effect of lath structures and low hardness of the weld metal minimize the deterioration effect of diffusible hydrogen. The presence of acicular ferrite in the weld metal (Fig.7) prohibiting the propagation of cracks initiated within the grains.

On the other hand, a ductile fracture is observed with a dimples at the weld metal as shown in Fig. 16. The existence of acicular ferrite in the weld metal (Fig. 7) increases its ductility.

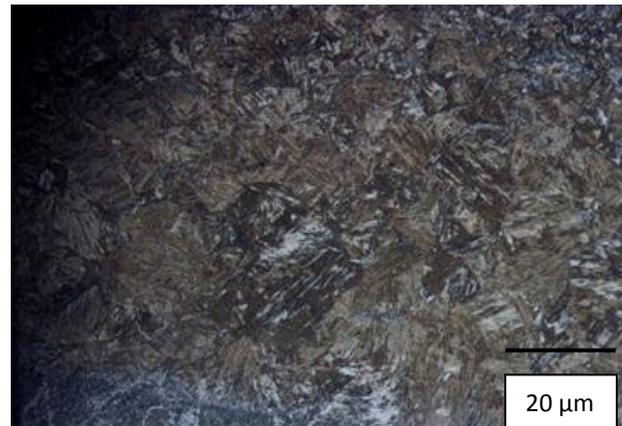
Figure 8 shows the microstructure at the heat affected zone (HAZ) which is a martensitic structure (at the grain coarsening zone).

**Fig. 8** microstructure at the heat affected zone (HAZ)

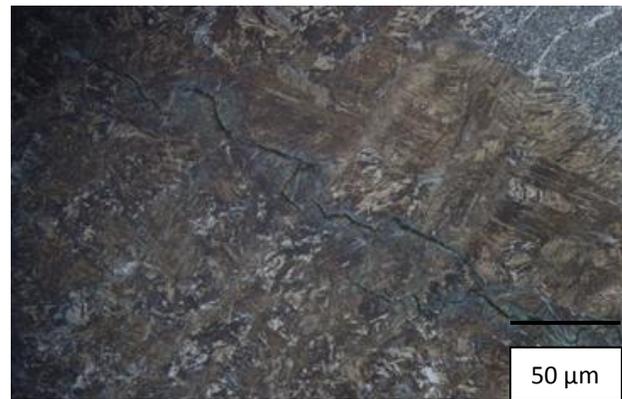
**Fig. 9** Microstructure at the cracked HAZ

Figure 9 shows the microstructure at the cracked heat affected zone (HAZ) which show that the structure is martensitic structure.
